NBSIR 83-2701

Comparative Analysis of Thermographic Inspections Performed on Retrofitted Homes

May 1983

Yui-May L. Chang
Richard A. Grot

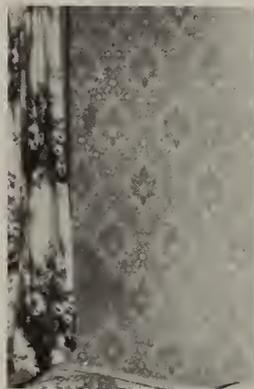
1-3
E of SE bedroom
(by contractor A1)

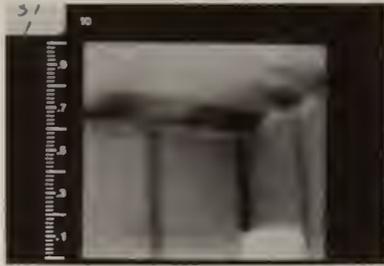
2-1
Lack of insulation in NE
ceiling of living room
(by contractor A2)

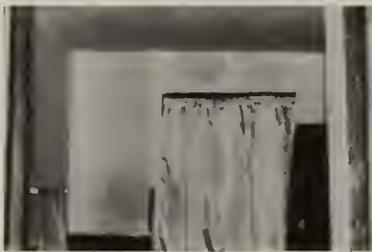
2-3
Uninsulated W wall
of bathroom
(by contractor A1)

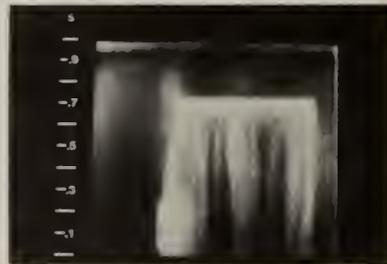
2-4
Uninsulated W wall
of bathroom
(by contractor A1)

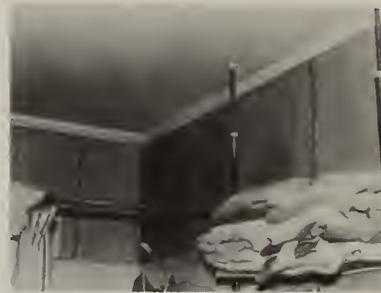
3-5

E (partition) wall
of bathroom
(by contractor A1)

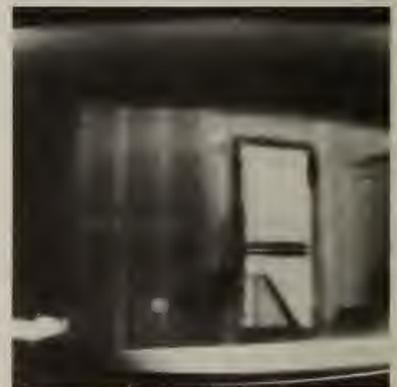
3-9

Insulation voids
around back door
in kitchen, exterior
(by NBS)

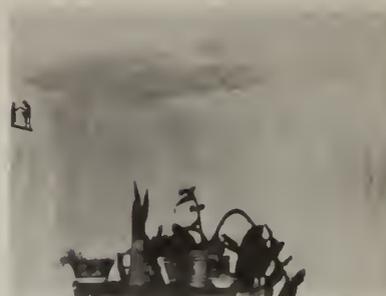
4-2

NE corner of living room
(by contractor A1)

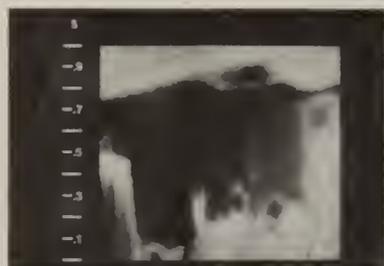
4-3

Uninsulated wall and
ceiling areas at NE
corner of living room
(by contractor A1)

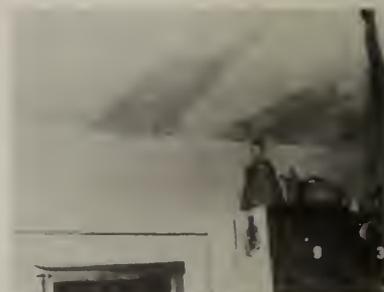
4-5

S wall of
kitchen (by
contractor A1)

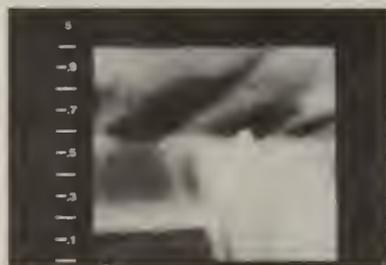
4-6

Voids above back door
and missing insulation
in S ceiling of kitchen
(by contractor A1)

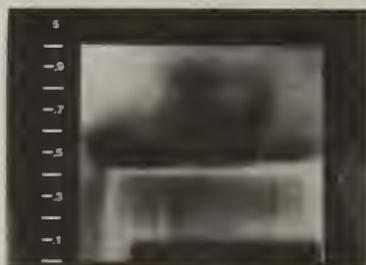
4-7

Voids above window
and defective ceiling
on S wall of bathroom
(by contractor A1)

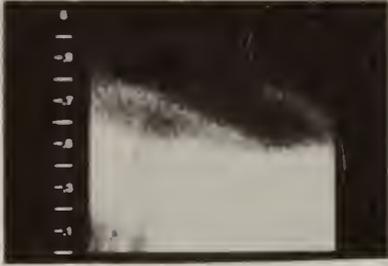
5-1

Lack of insulation in
living room ceiling
(by contractor C2)

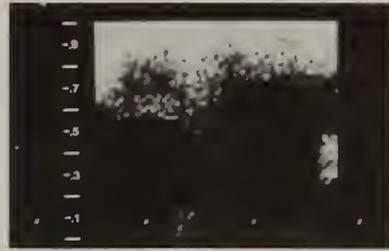
6-2

Poor quality of documentation to show defects on N wall of kitchen (by contractor C2)

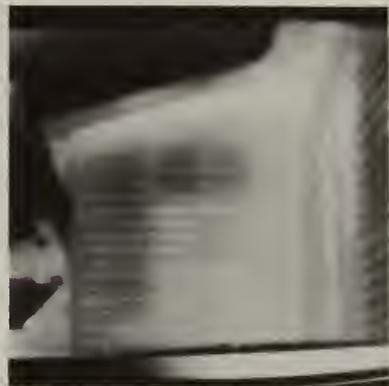
6-4

Insulation voids in three bay areas on E wall of bathroom shown in exterior thermogram (by NBS)

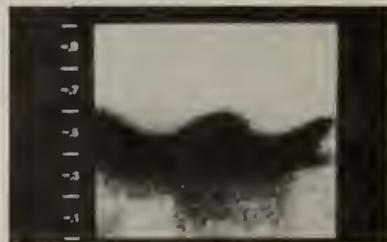
7-2

Defective ceiling as shown in 7-1 (by contractor C2)

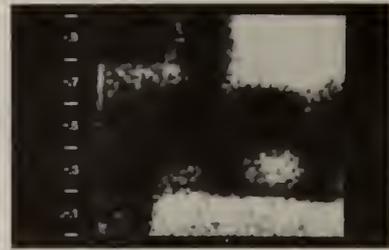
8-2

Defects in N wall of living room as shown in 8-1 (by contractor C2)

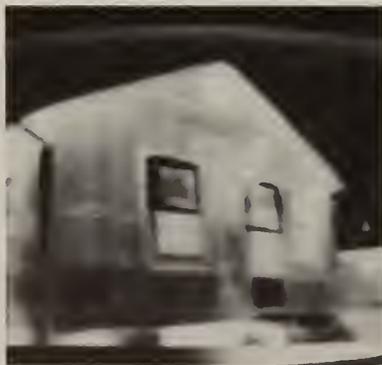
8-5

Defective areas on W side shown in exterior thermogram (by NBS)

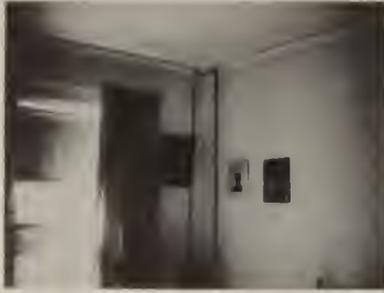
9-1

Partial bay cavity at SW corner of SW bedroom on 1st floor (contr.M2)

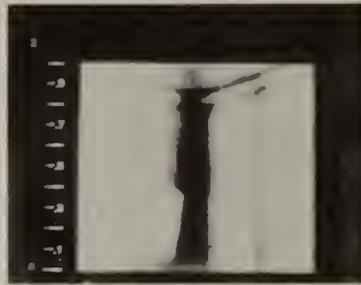
9-2

Partial bay cavity at SW corner shown in 9-1 (by contractor M2)

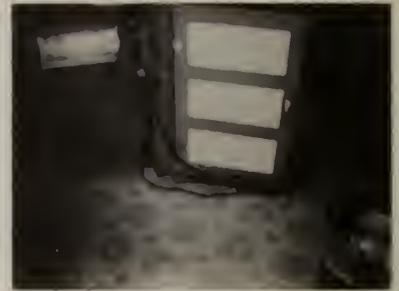
9-3

area under cabinet N of kitchen on 1st floor (by contr.M2)

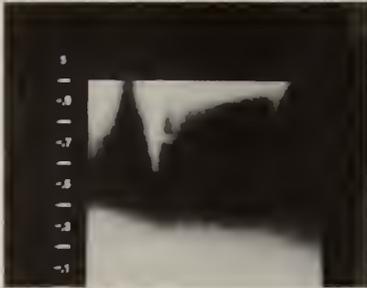
9-4

Air penetration from floor under cabinet, N of kitchen on 1st floor (by contractor M2)

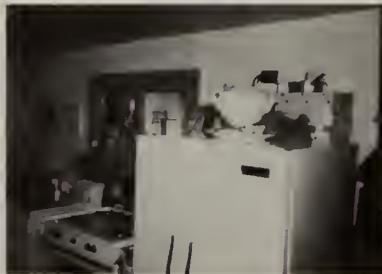
9-5

E wall of kitchen on first floor (by contractor M2)

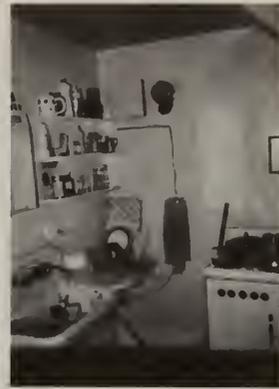
9-11

N wall (with junction box) of kitchen on 2nd floor (by contractor M3)

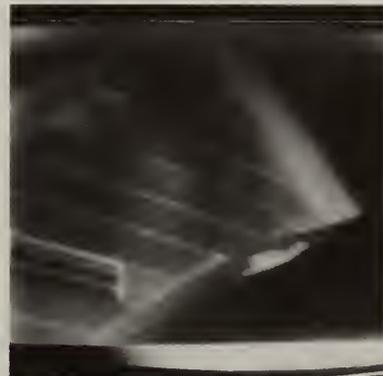
9-13

Cold area of junction box in 9-11, shown in ext. thermogram (by NBS)

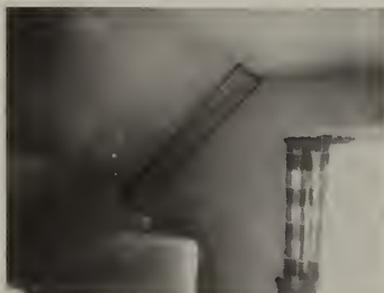
9-14

Uninsulated bay cavity in pitched ceiling at NE corner of kitchen on 2nd floor (by contractor M2)

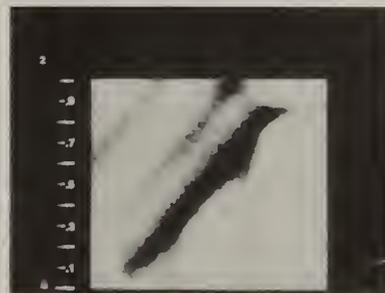
9-15

Uninsulated bay cavity in pitched ceiling at NE corner of kitchen on 2nd floor (by contractor M2)

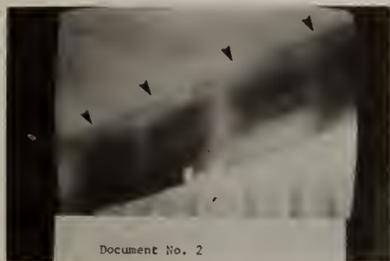
10-1
Interior thermogram
of voids above window
in W wall of SW
bedroom (by contr.M1)

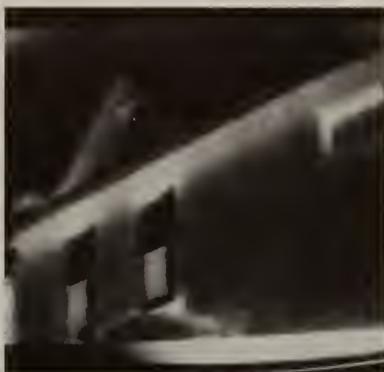
10-2
Exterior thermogram
exhibits defects on
W wall of living room
SW bedroom (by NBS)

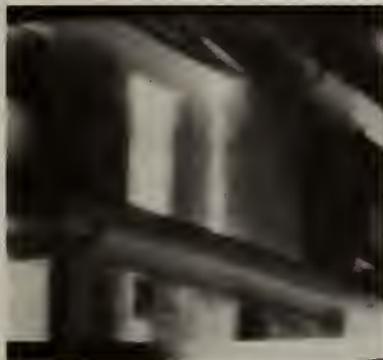
10-4
Exterior thermogram of
10-3, warm areas above
window and at corner
(by NBS)

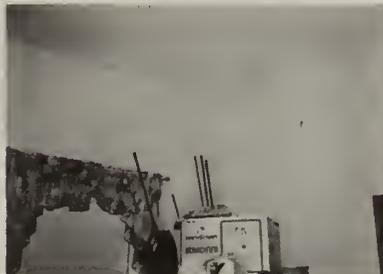
10-5
N partition wall
of kitchen (by
contractor M3)

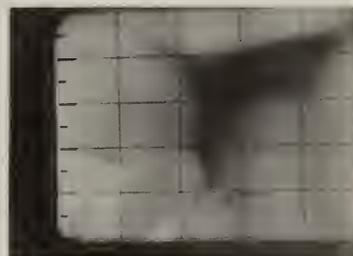
10-6
Air penetration in N
partition of kitchen
(by contractor M3)

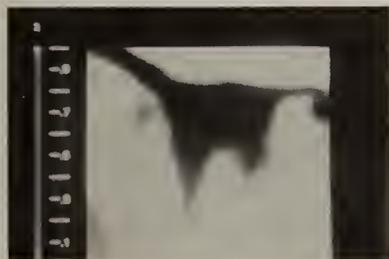
10-7
Air penetration in N
partition wall of
kitchen (by contr.M2)

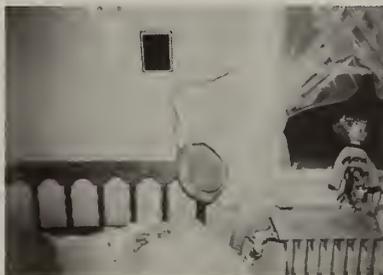
10-8
N wall of N bedroom
(by contractor M3)

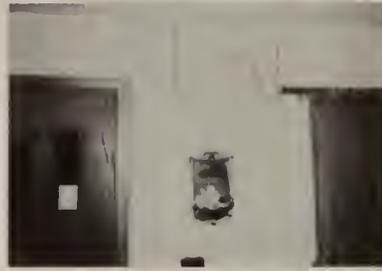
11-2
W wall of living room (by contractor M3)

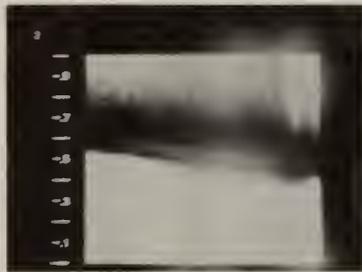
11-4
Air infiltration under front door (by contractor M2)

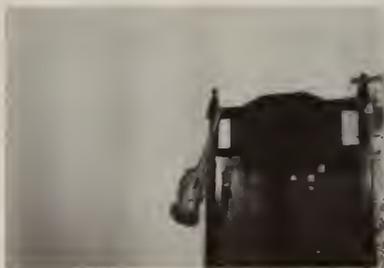
11-7
SE corner of SE bedroom (by contractor M3)

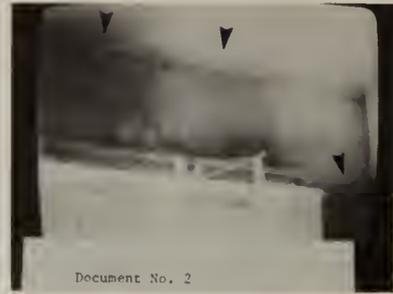
12-2

Same defective areas as observed in 12-1 (by contractor M1)

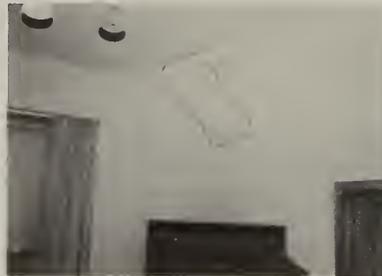
12-4

NE corner in N bedroom upstairs (by contractor M3)

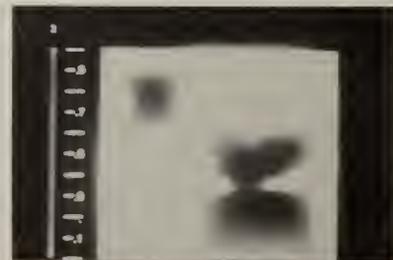
12-7

Defective areas observed on S wall of kitchen on second floor as in 12-6 (by contractor M2)

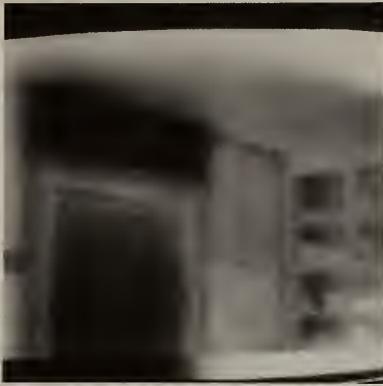
13-1

Voids above window on S wall and air infiltration at SW corner of kitchen on first floor (by NBS)

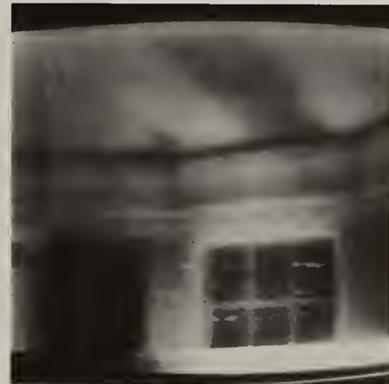
13-4

Voids in ceiling above middle window on N wall of living room on first floor (by NBS)

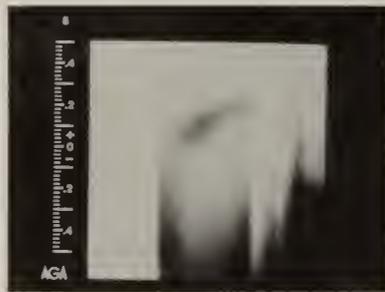
17-3
Shrinkage of insulation on
W wall of kitchen (by contr.W2)

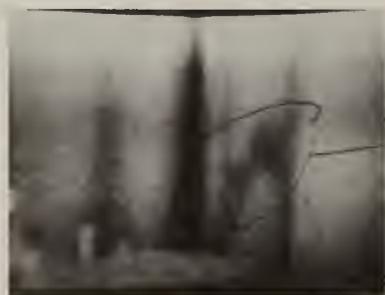
17-5
Shrinkage or fissures
at E corner of S wall in
SE bedroom (by contr.W4)

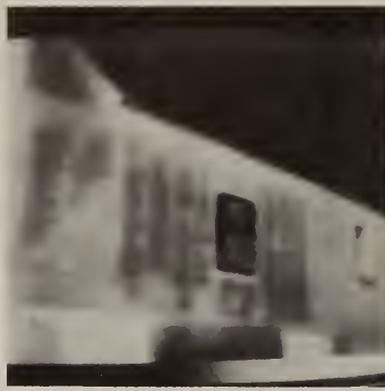
18-2

Exterior thermogram
depicts the different
insulation levels be-
tween dining room and
SW bedroom from W wall
(by NBS)

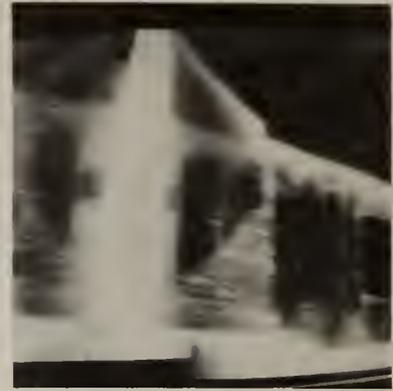
18-3

Exterior thermogram
shows the unfilled areas
and air penetration from
old chimney on W of NW
bedroom (by NBS)

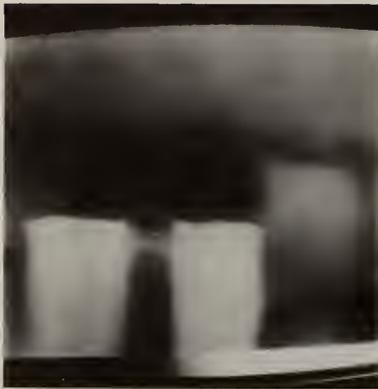
18-4

Voids above window in N wall
of NW bedroom (by NBS)

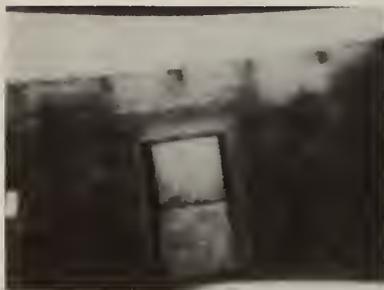
18-6

Defects observed as
in 18-4 and 18-5,
from the exterior
(by contractor W4)

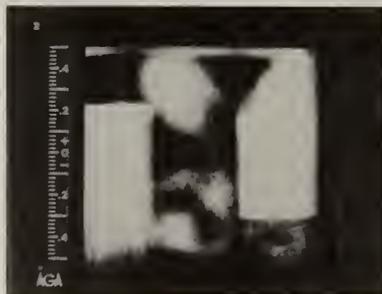
18-7

Voids above and on
S side of window in
E wall of living
room (by contr. W2)

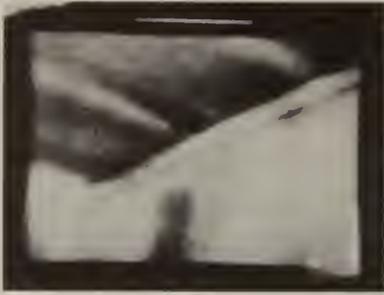
19-1
Uninsulated ceiling joints
from N to S in living room
(by contractor W4)

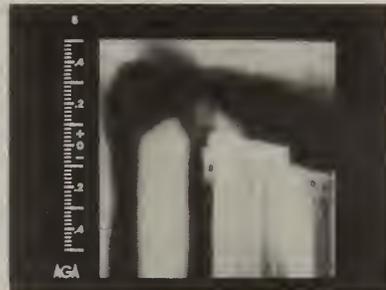
20-5

Voids above window and in 2 partial bay cavities on S of window of W wall of NE bedroom on 2nd floor (by contractor W2)
